LAKE DENMARK DAM  
NJ 00001

PHASE 1 INSPECTION REPORT  
NATIONAL DAM SAFETY PROGRAM.

Lake Denmark Dam (NJ-00001). Passaic River  
Basin. Green Pond Brook, Morris County,  
New Jersey. Phase 1 Inspection Report.

September 1979

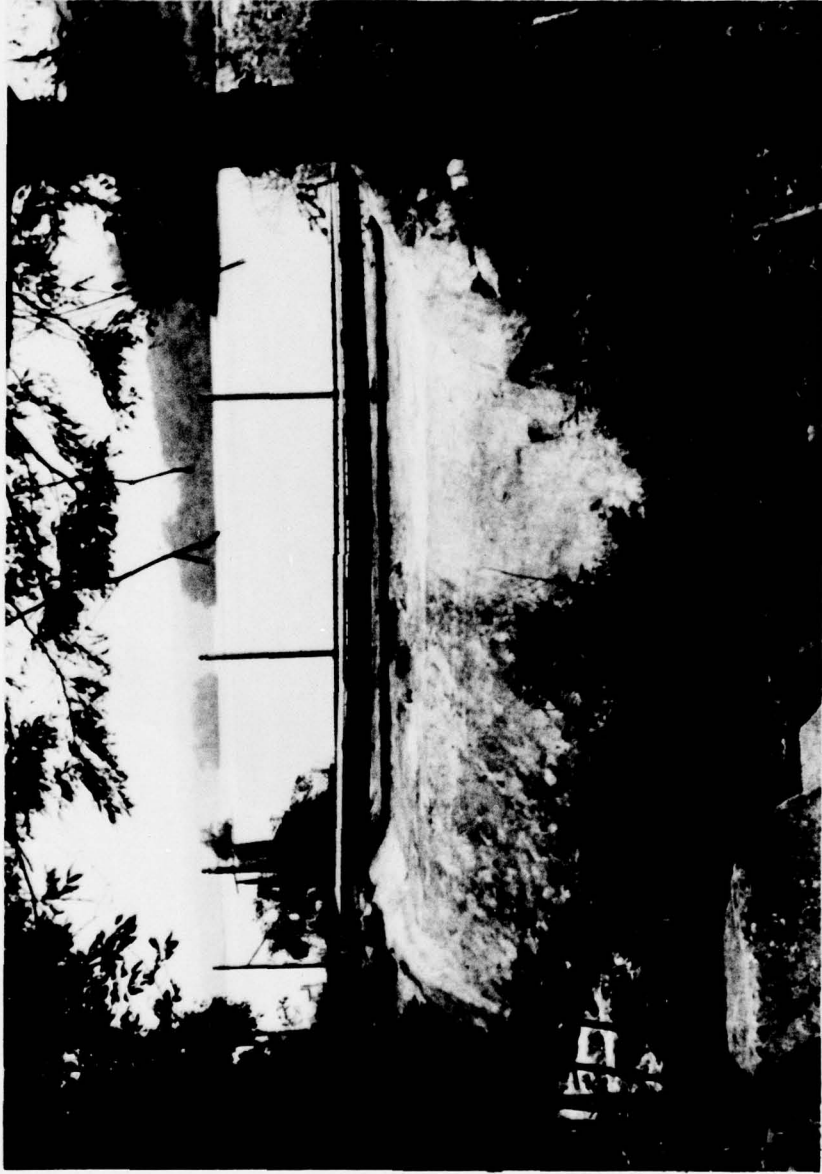
Lake Denmark Dam  
View of spillway and lake from downstream.

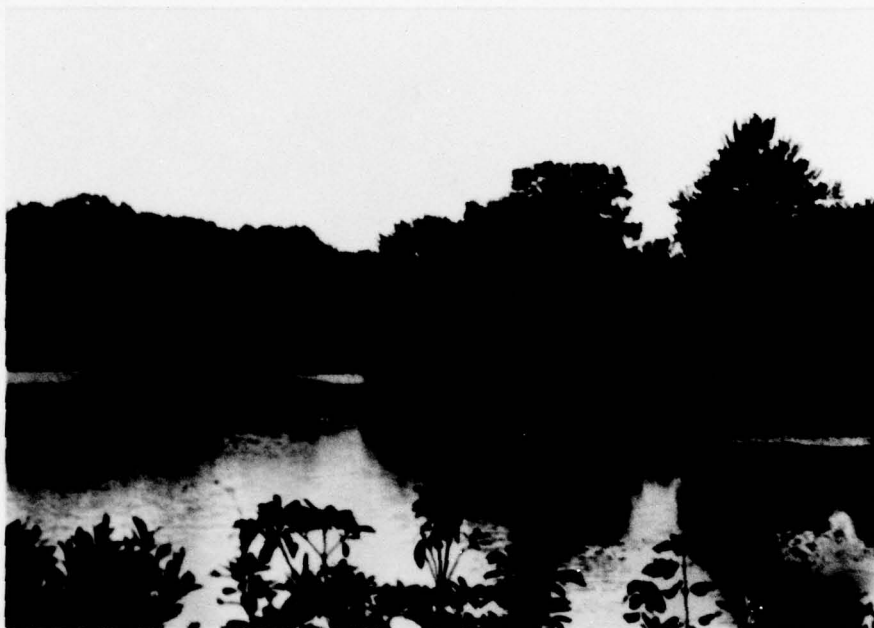
Photo No. 1 - Overall view of upstream face of dam. Note the heavy tree-growth on the dam, the spillway to the right of center and the boating facilities to the left. Note also the power cables across the dam and the building downstream.

VISUAL EXAMINATION OF	OBSERVATIONS	REMARKS AND RECOMMENDATIONS
TREES & VEGETATION	A dense growth of trees and brush is covering a large amount of the dam.	Remove trees growing on the crest, over the road culverts, and on the downstream slope.
JUNCTION OF EMBANKMENT AND ABUTMENT, SPILLWAY AND DAM	Junctions appear sound. No leakage noted. Crest is protected by concrete bags on both sides of the spillway.	
ANY NOTICEABLE SEEPAGE	None. The downstream slope below the road was examined, as were downstream channel banks to 200 feet below the culvert.	Check for signs of seepage at each O & M inspection.
STAFF GAGE AND RECORDER	Headwater gage only, located at the end of a short pier, showing water level in lake to MSL in 0.1' graduations. Gage is in good condition.	Check gage datum when performing topographic survey of dam. Install a tailwater gage.
DRAINS	None.

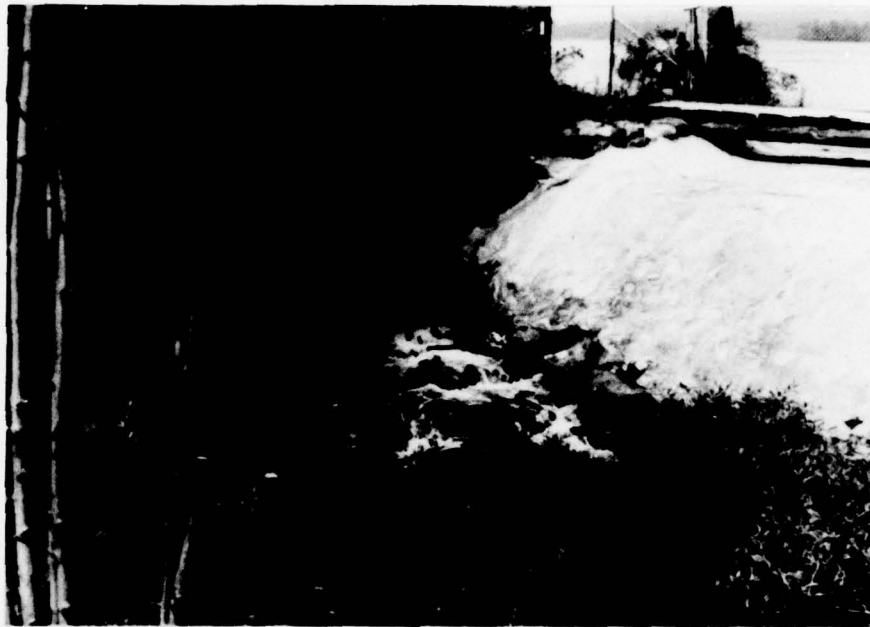
All low-level outlets were operated, and seen to be in good working condition. On the day of inspection, the reservoir was 1 to 2 feet below the spillway crest. All three low-level outlets were partially open; presumably in order to maintain a flow in the channel. The fish-trap through which the 12-inch diameter pipes discharge was totally deteriorated.

Photo No. 3 - View of right side of spillway. Discharge from the lake was through the two 12" diameter low-level outlets. What is assumed to have been a fish trap at the discharge end, is now totally deteriorated.

VISUAL EXAMINATION OF	OBSERVATIONS	REMARKS AND RECOMMENDATIONS
<p>CRACKING &amp; SPALLING OF CONCRETE SURFACES IN STILLING BASIN</p>	<p>The structure is not provided with a stilling basin. The discharge channel is rocky and effectively dissipates the energy of the flow.</p>	
<p>INTAKE STRUCTURE</p>	<p>Upstream ends of the two 12" <math>\phi</math> low-level outlet pipes terminate in a small concrete headwall located on the upstream slope of the embankment. The intakes were visible below the surface of the lake and were in good condition. The intake for the 24" <math>\phi</math> low-level outlet was not visible.</p>	
<p>OUTLET STRUCTURE</p>	<p>The two 12" <math>\phi</math> outlets terminate at the right side of the discharge channel immediately adjacent to the spillway. The 24" <math>\phi</math> outlet terminates at the left side of the channel. The discharge areas on both sides are rock-covered and erosion is not a problem. The 12" <math>\phi</math> outlets discharge through a deteriorated fish-trap.</p>	<p>Repair fish-trap if required.</p>

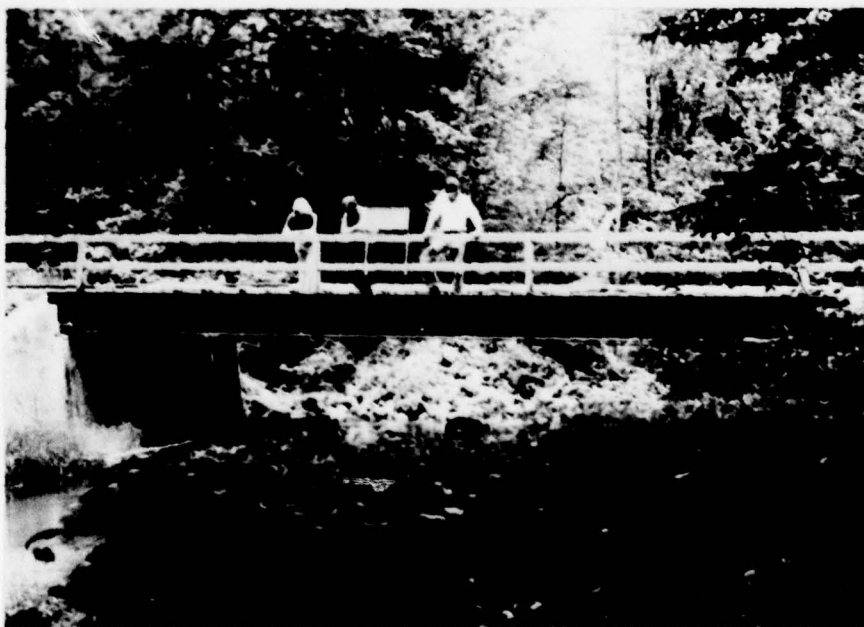
Photo No. 10 - View of railroad bridge 1,700 feet downstream of dam.
